Cultured Stone Veneer

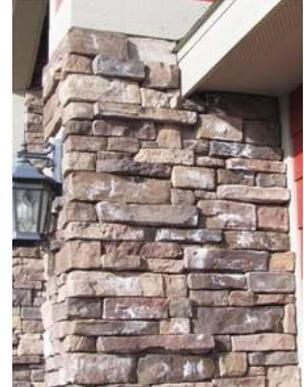
Water damage to cultured stone veneer due to poor roof flashing

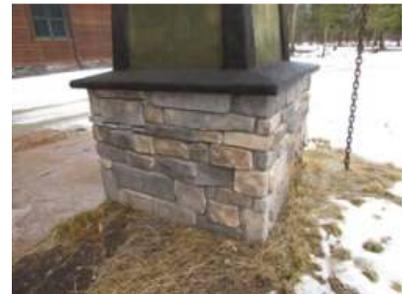
Problems also commonly show up when a contractor extends the siding to, or even into the ground. Screeds and other base flashings should be held a minimum of 4" above grade and a minimum of 2" above hard surfaces such as driveways, patios, etc. Even though the exterior surface may be weather resistant, when the plywood or OSB backer sheathing is in contact with wet surfaces or soil, the OSB soaks up moisture like a sponge and will rot sooner or later.

This sturdy looking column base will eventually crumble, as the OSB box it is built on will rot away like wet cardboard.
