Electrical fires

History of Aluminum wiring

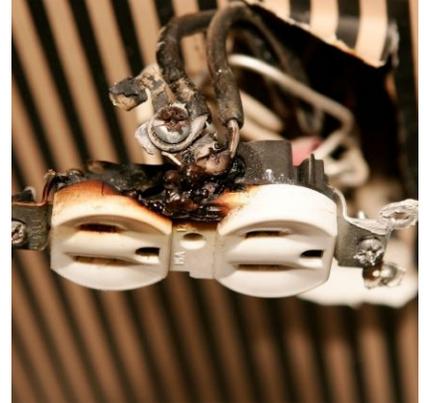
There are several challenges with using aluminum for wiring. Aluminum expands and contracts with current more than copper, which can lead to loose connections at wire terminals that can create arcing and electrical fires.

Aluminum can be prone to oxidation forming on the wires that can cause a poor connection and increased resistance, resulting in overheating. Wiring two dissimilar metals together like aluminum and copper can also lead to galvanic corrosion and increased resistance, again leading to overheating. It is more ductile than copper and will break easier with repeated bending or movement. As a side note, some insurance companies may decline to offer coverage if the wiring is present or may come at a higher cost.

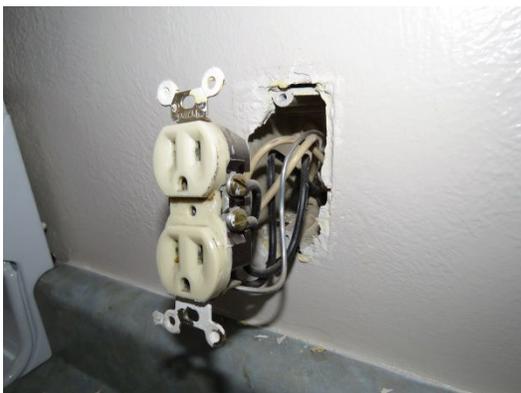
The wiring that gained notoriety as a cause of fires was the aluminum "Romex®" (non-metallic thermoplastic insulation) found in homes built between 1964 and 1972. An improved aluminum alloy that appeared in 1973 didn't become absolutely required until the 1981 edition of the NEC. While the older aluminum alloy is a significant safety issue, the newer single-strand alloy is still a concern. As a home inspector, while we can see if it is a copper or aluminum wire, we cannot determine whether it is the older or newer alloy.

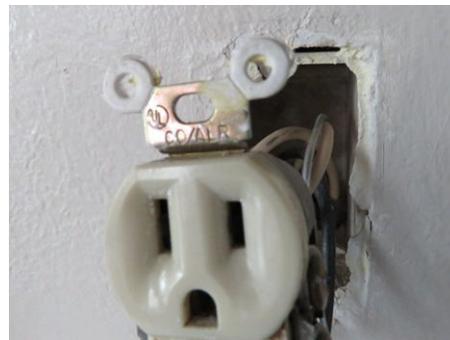
CO/ALR electrical receptacle

An improved "CO/ALR" standard that appeared in the 1973 timeframe included terminal screws better designed to prevent aluminum wires from becoming loose. Prior to this time, it was optional for the manufacturers to label device compatibility with aluminum wiring, therefore we don't always know if the appropriate device is being used.

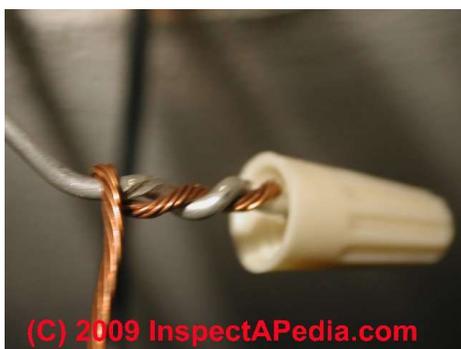
*Wrong. Can't use just any wire nut.
Common nuts loosen and allow corrosion*

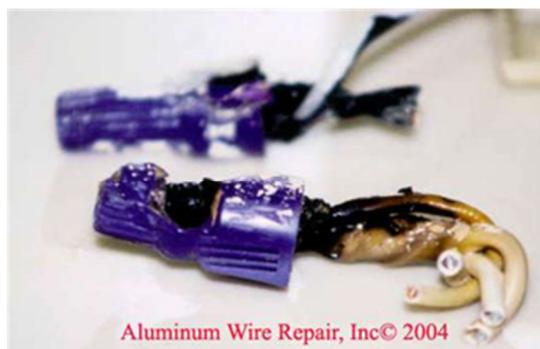
*Ideal "65" twist connector, originally
recommended for aluminum pigtails, often fail*

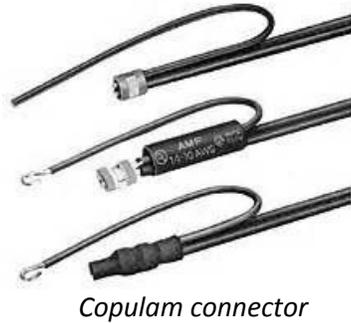
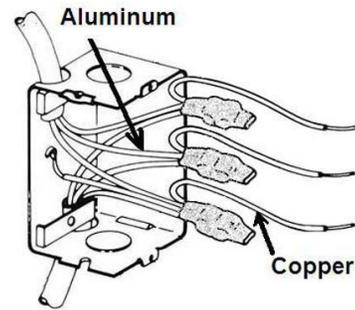
In many cases, copper 'pigtails' using Copulam crimps may need to be added so the end of the circuit that connects to devices is copper. This work should only be done by licensed electricians certified with the Copulam repair method. Other connectors are now also available, but have not been subjected to exhaustive testing.
